**ADVANCED ACS VALVE  
SEALING SURFACE COMPATIBILITY  
INVESTIGATION**

G. R. Pfeifer  
H. Wichmann  
Dr. R. Kratzer

This is the final report on the Advanced ACS Valve Sealing Surface Compatibility Investigation performed by The Marquardt Company, CCI Aerospace Corporation, Van Nuys, California, for the Air Force Rocket Propulsion Laboratory under contract FO-4611-70-C-0052 dated 20 April 1970. This task was conducted under the USAF Project 3058. The objective of the program was to determine the causes leading to leakage of the Marquardt Advanced ACS Valve when operated using chlorine pentafluoride or gaseous fluorine as propellants. Objectives of the program were accomplished with design data developed which can lead to a completely successful seat and poppet closure. The period of performance covered by this report is from 15 May 1970 through 15 July 1971. Edwin L. Lantzer, 1st Lt., USAF was the AFRPL Project Engineer for the program.

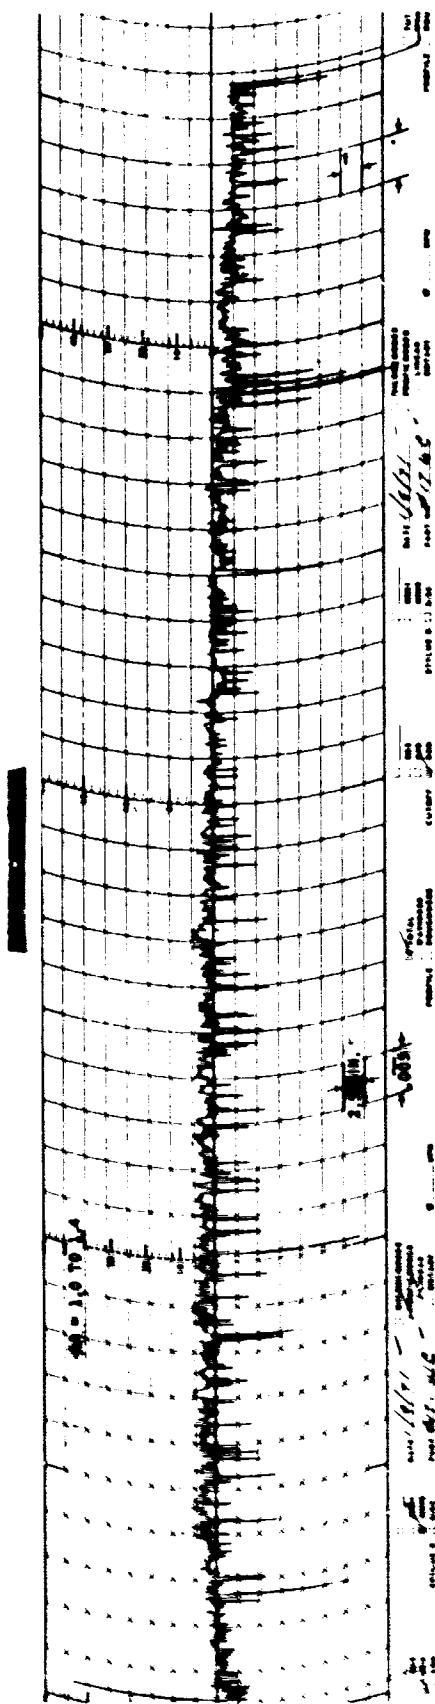
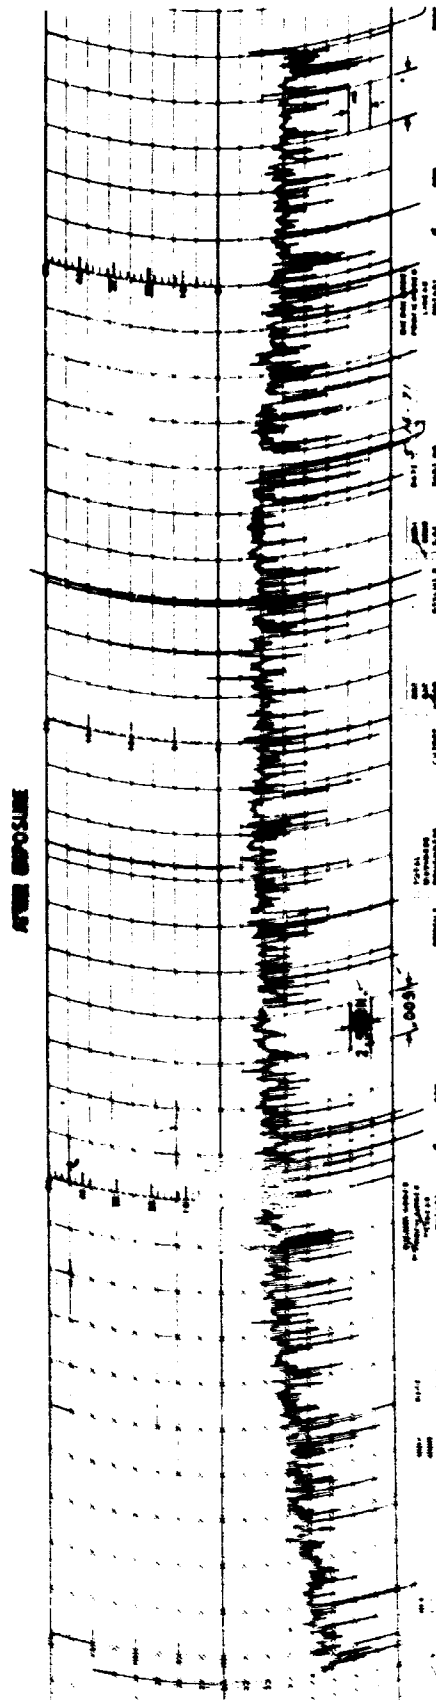
Figure 43

# WC - TUNGSTEN CARBIDE SURFACE PROFILE BEFORE AND AFTER CIF5 STATIC EXPOSURE

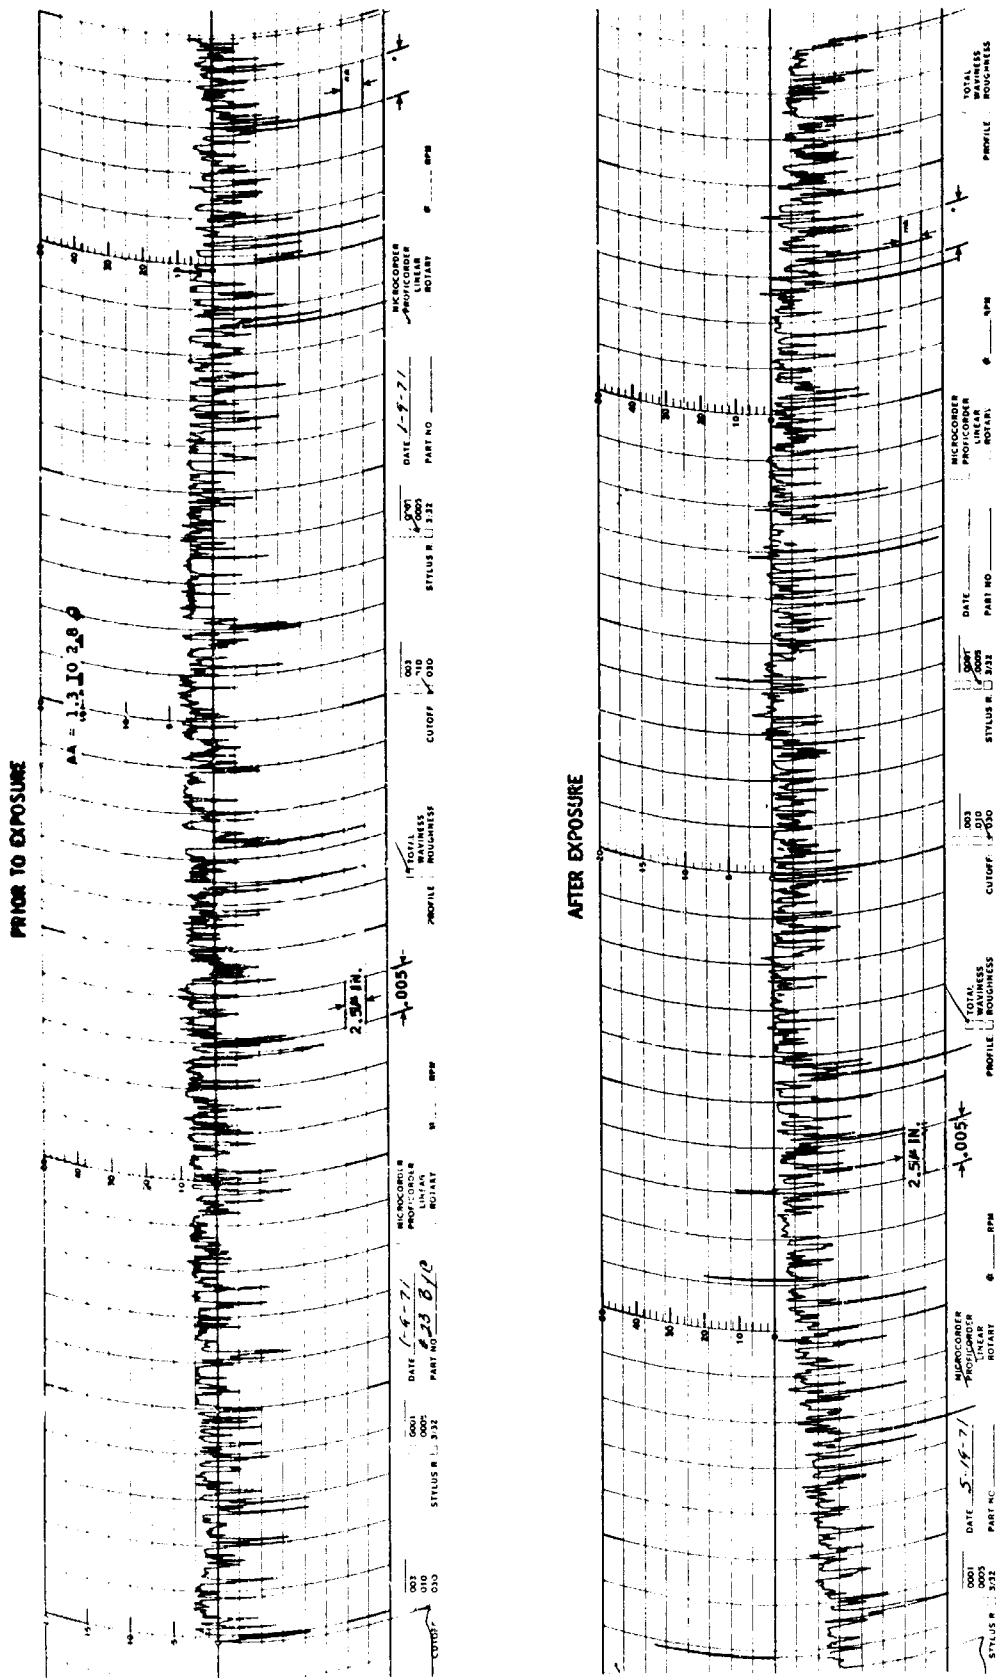
Figure 45 100

AL2 03  
SURFACE PROFILE BEFORE AND AFTER CIF5 STATIC EXPOSURE

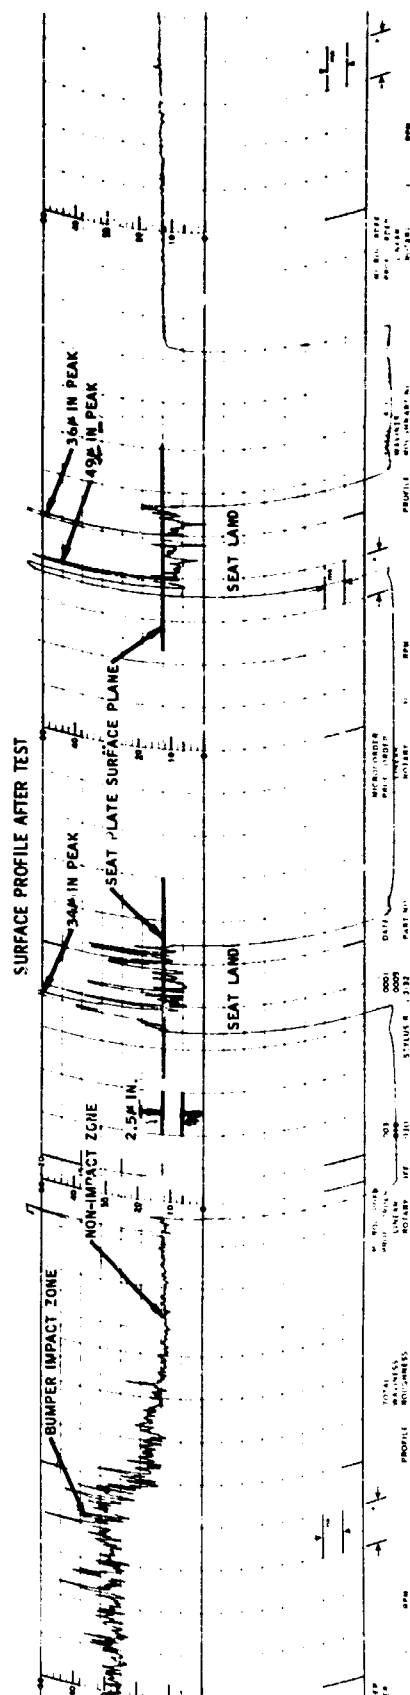
Figure 59

These results are similar to previous test results which indicated positive growth of deposits in the seating surface. Examination of some further photographs of the seat surface (Figure 60) shows that the nonimpacted zones are very similar to the surfaces of the statically exposed poppets. The general seat land surface was domed after the valve test exposure indicating some loss of material from the edges of the seat.

# NI-301 SEAT SURFACE PROFILE BEFORE AND AFTER 100,000 CYCLE VALVE TEST - LOW IMPACT - CIF5

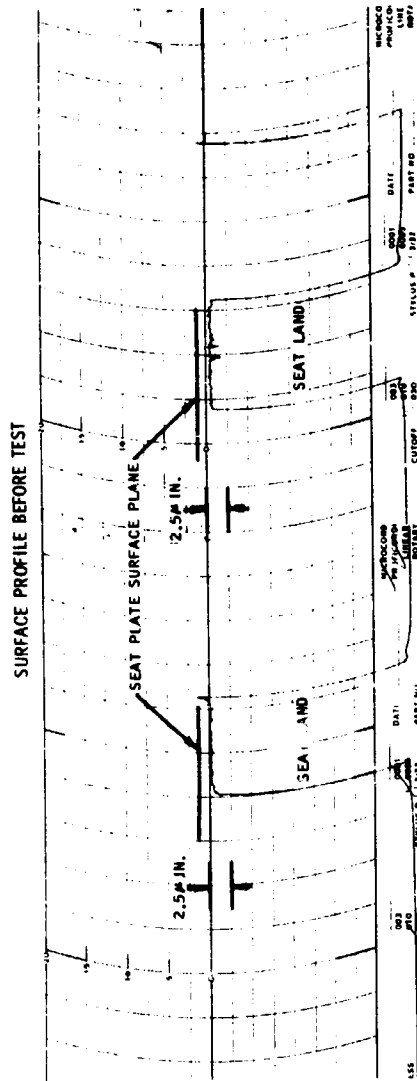
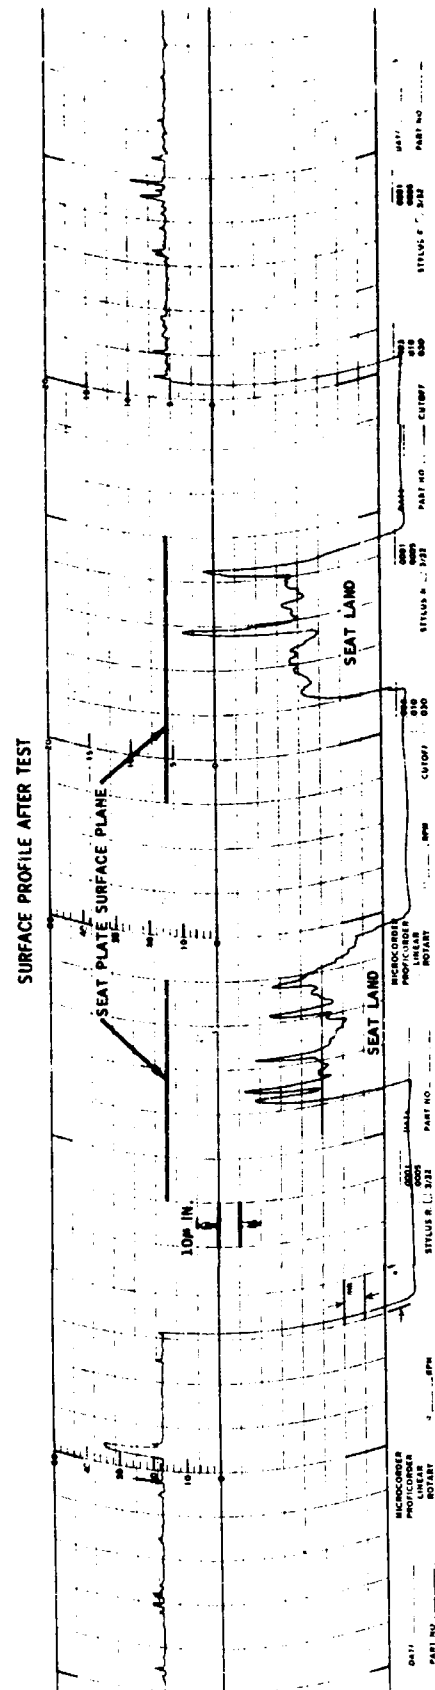
Figure 66

# K-96 SEAT SURFACE PROFILE BEFORE AND AFTER 100,000 CYCLE VALVE TEST - NORMAL IMPACT - CIF5

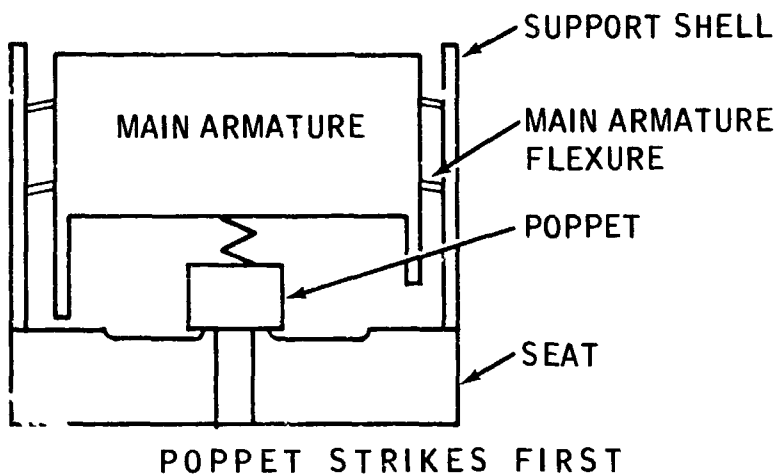
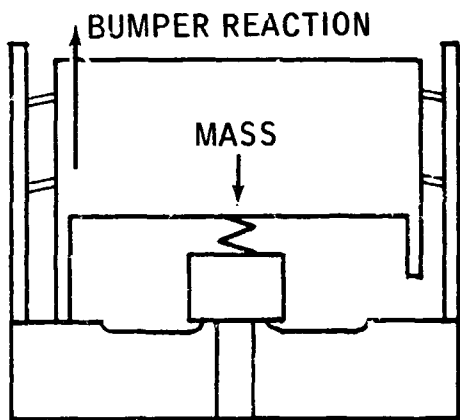
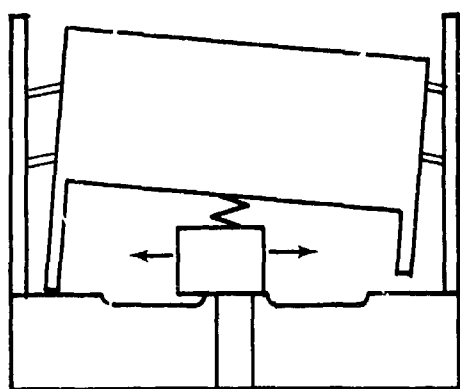
NONUNIFORM BUMPER IMPACT

NONUNIFORM BUMPER IMPACT CAUSES COUPLE

RESULT - LATERAL MOTION

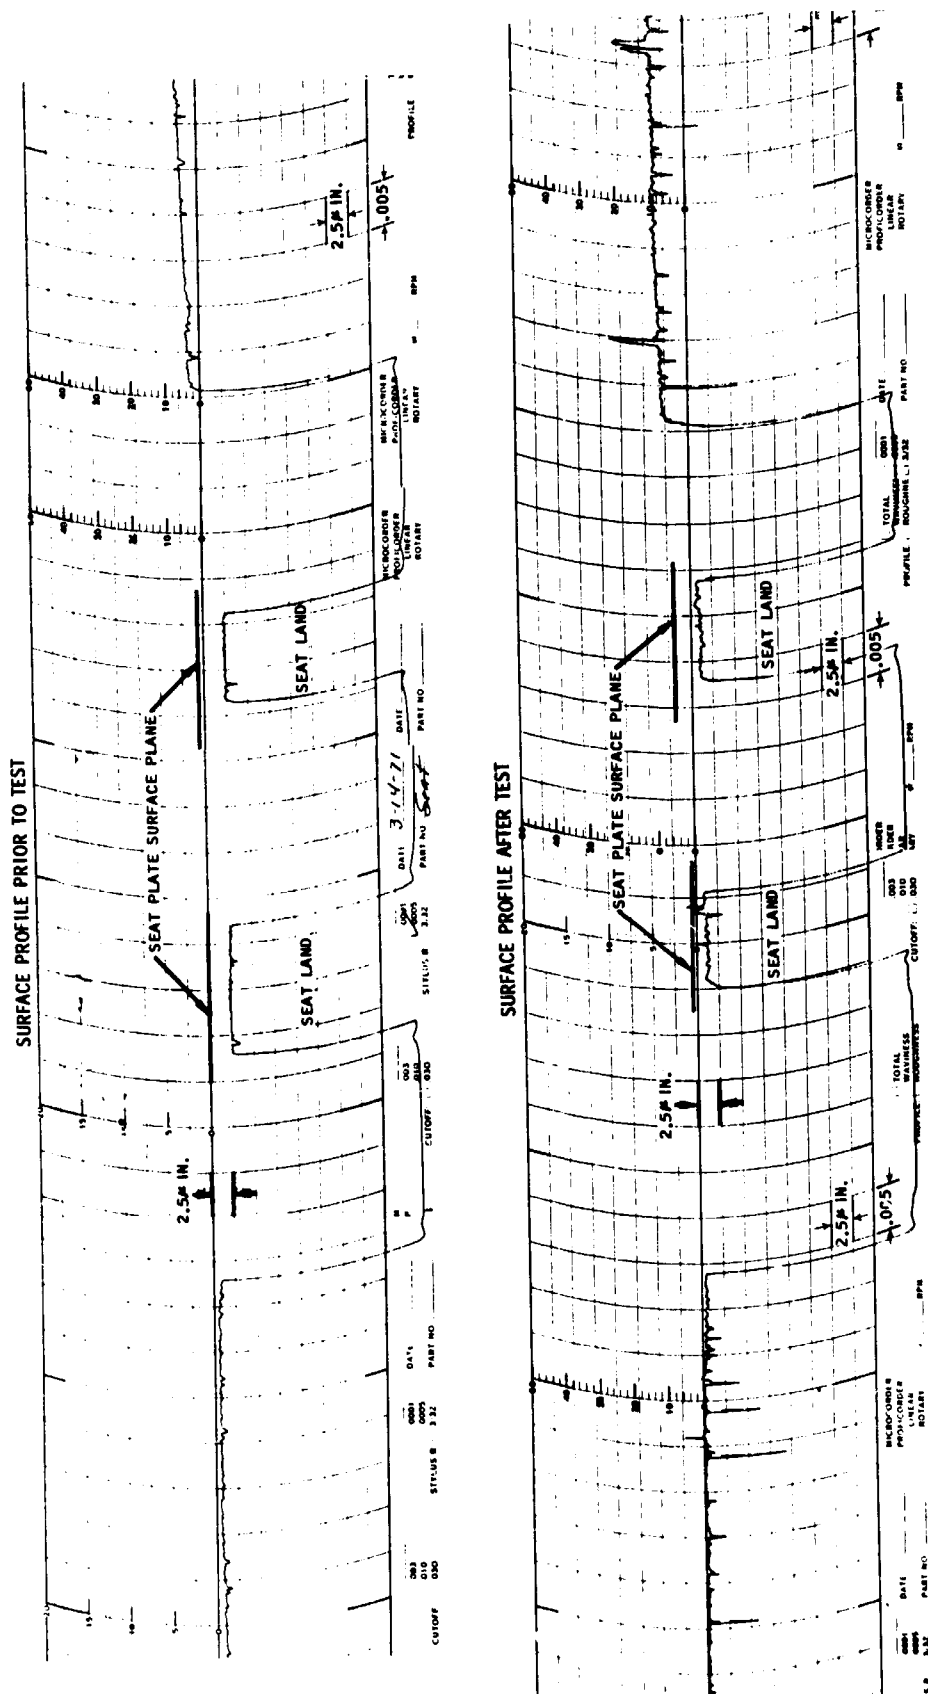
Figure 76

# B4 C SEAT SURFACE PROFILE BEFORE AND AFTER 100,000 CYCLE VALVE TEST - CIF5

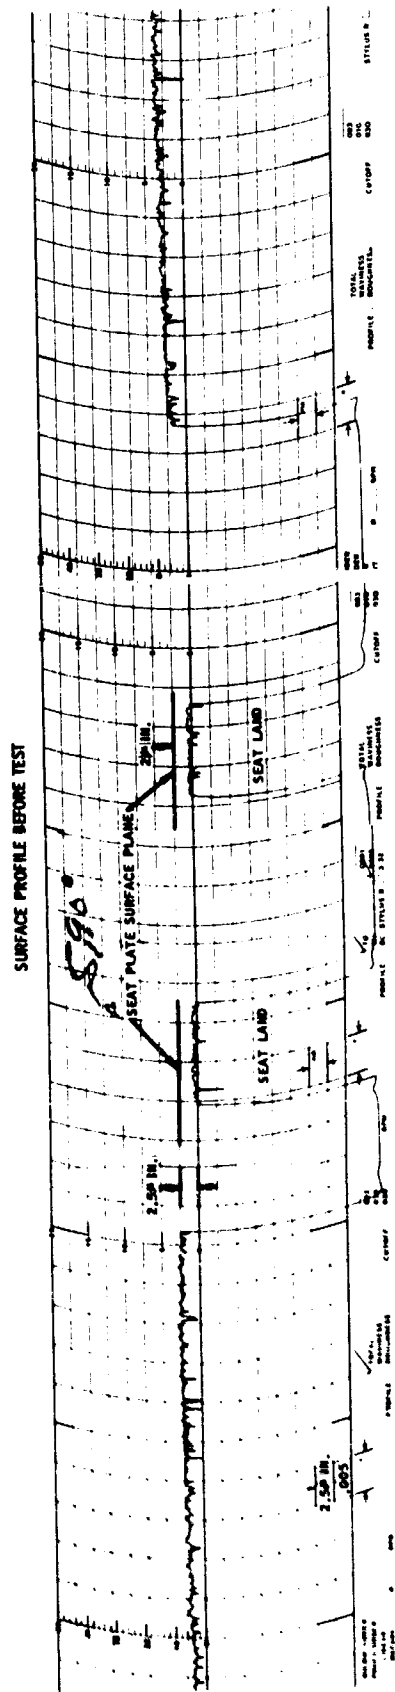
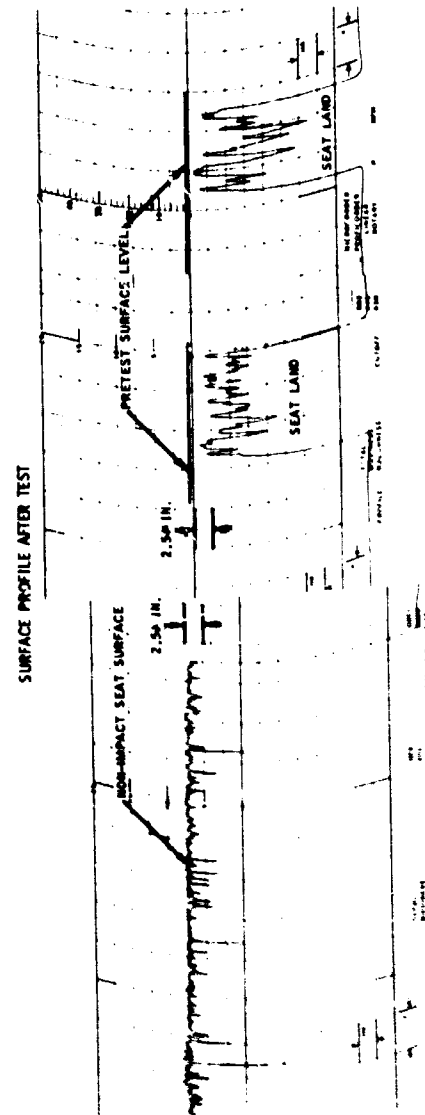
Figure 77

# BORON CARBIDE SEAT SURFACE PROFILE BEFORE AND AFTER 100,000 CYCLE VALVE TEST - NORMAL IMPACT - CIF5

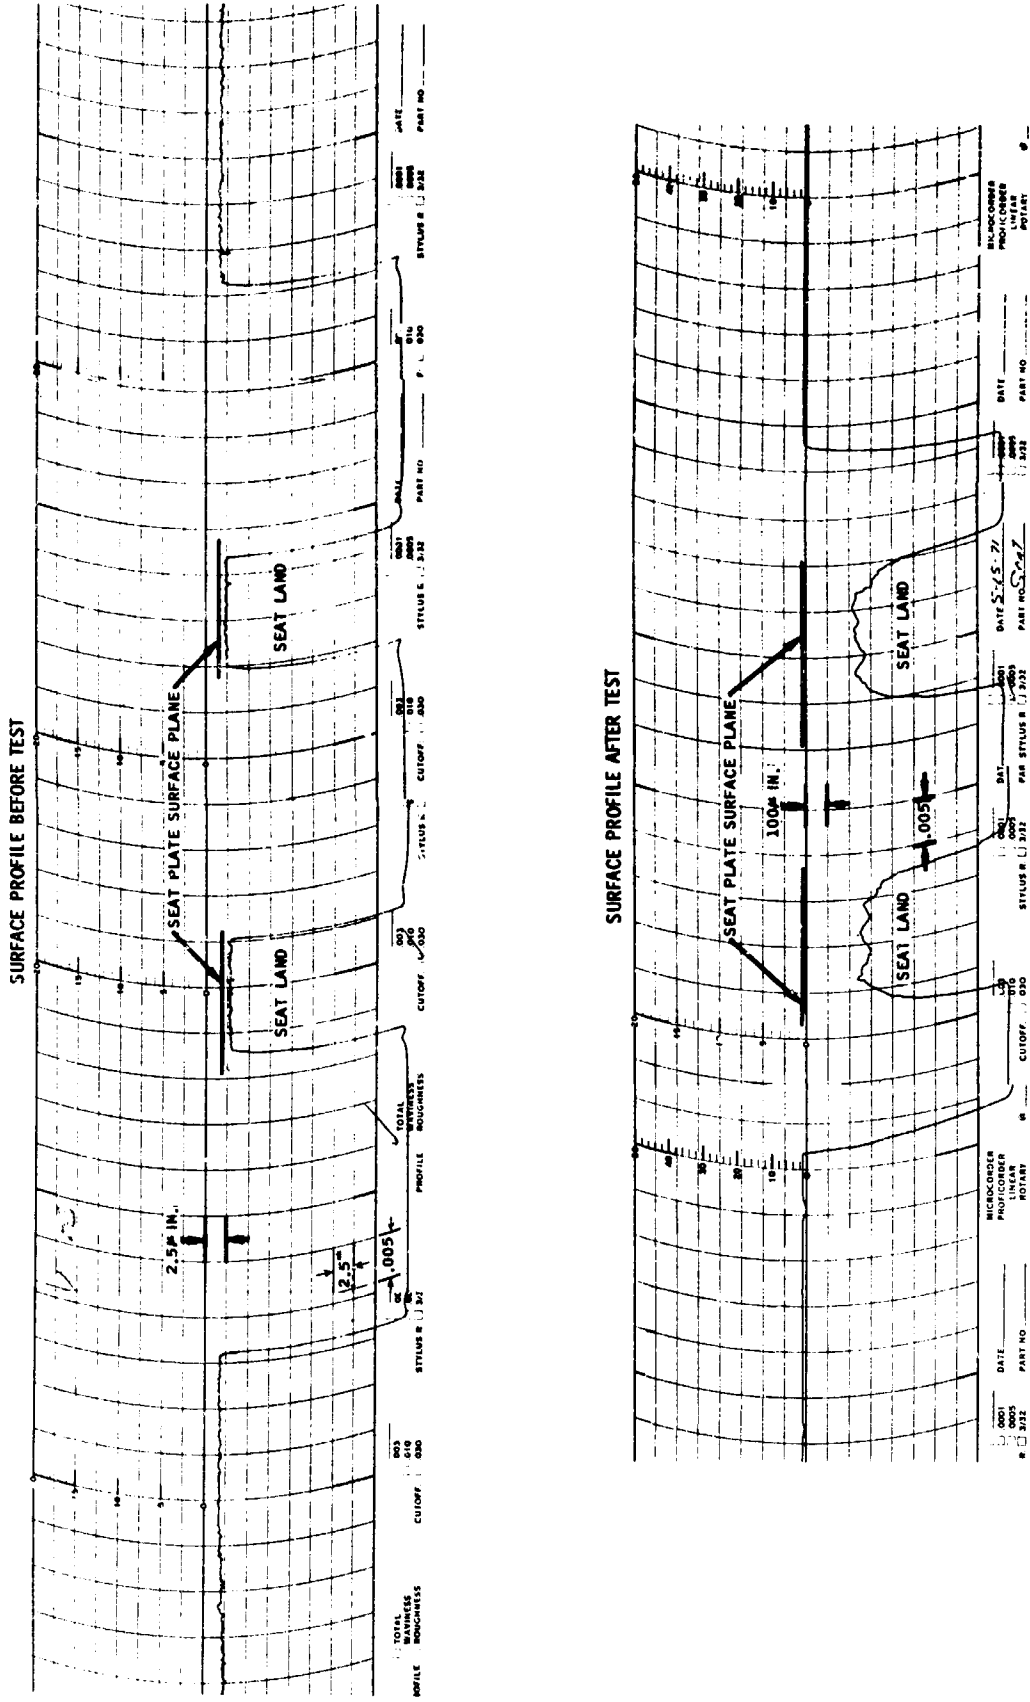
Figure 83

WC SEAT  
SURFACE PROFILE BEFORE AND AFTER 100,000 CYCLE VALVE TEST - NORMAL IMPACT - CIF5

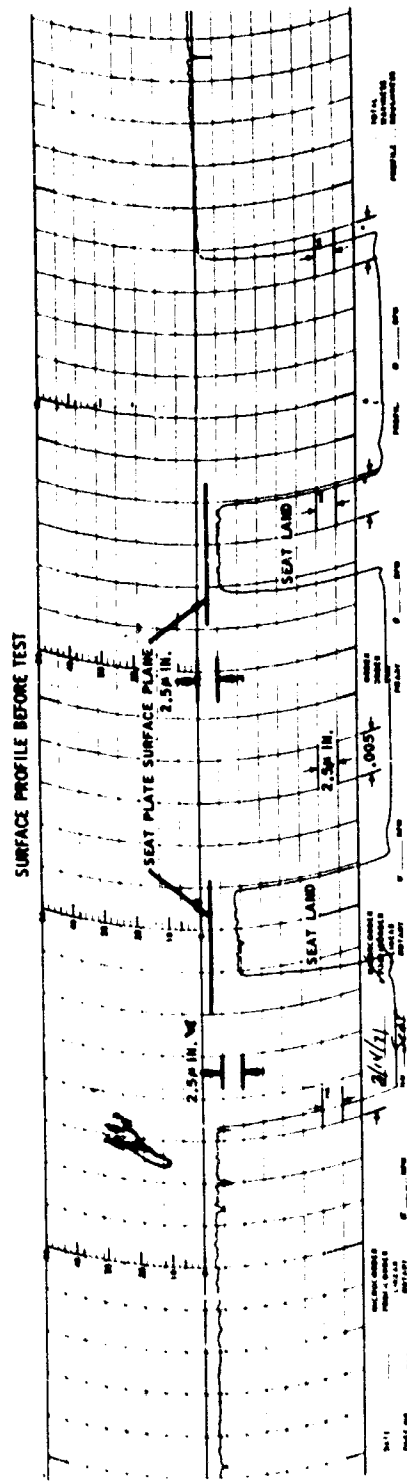
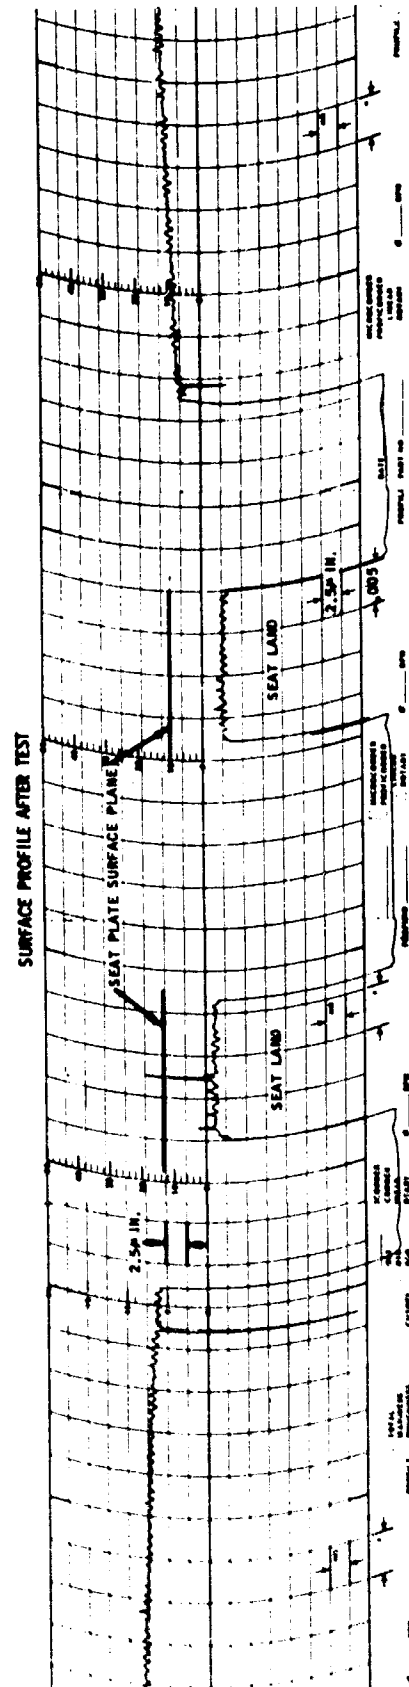
Figure 88

Loose debris was seen on several other samples during electron microscope examination, but only on the aluminum oxide parts was it apparently associated with the reaction of the propellants with the material. The buildup appears to be concentrated in the seal area and immediately downstream of the seal. The particles were too small to evaluate using the microprobe to determine composition. However, because of the location and distribution of the particles, they are assumed to be associated with the reaction of the aluminum oxide with the chlorine pentafluoride in the dynamic impact environment. Buildup of this debris, whether associated with the propellant/material reaction is the most probable cause of the progressively

**AL<sub>2</sub>O<sub>3</sub> SEAT**  
**SURFACE PROFILE BEFORE AND AFTER 100,000 CYCLE VALVE TEST - LOW IMPACT - CIF5**
